10/30/2020 Job Packet

www.clearwaterweedremoval.com

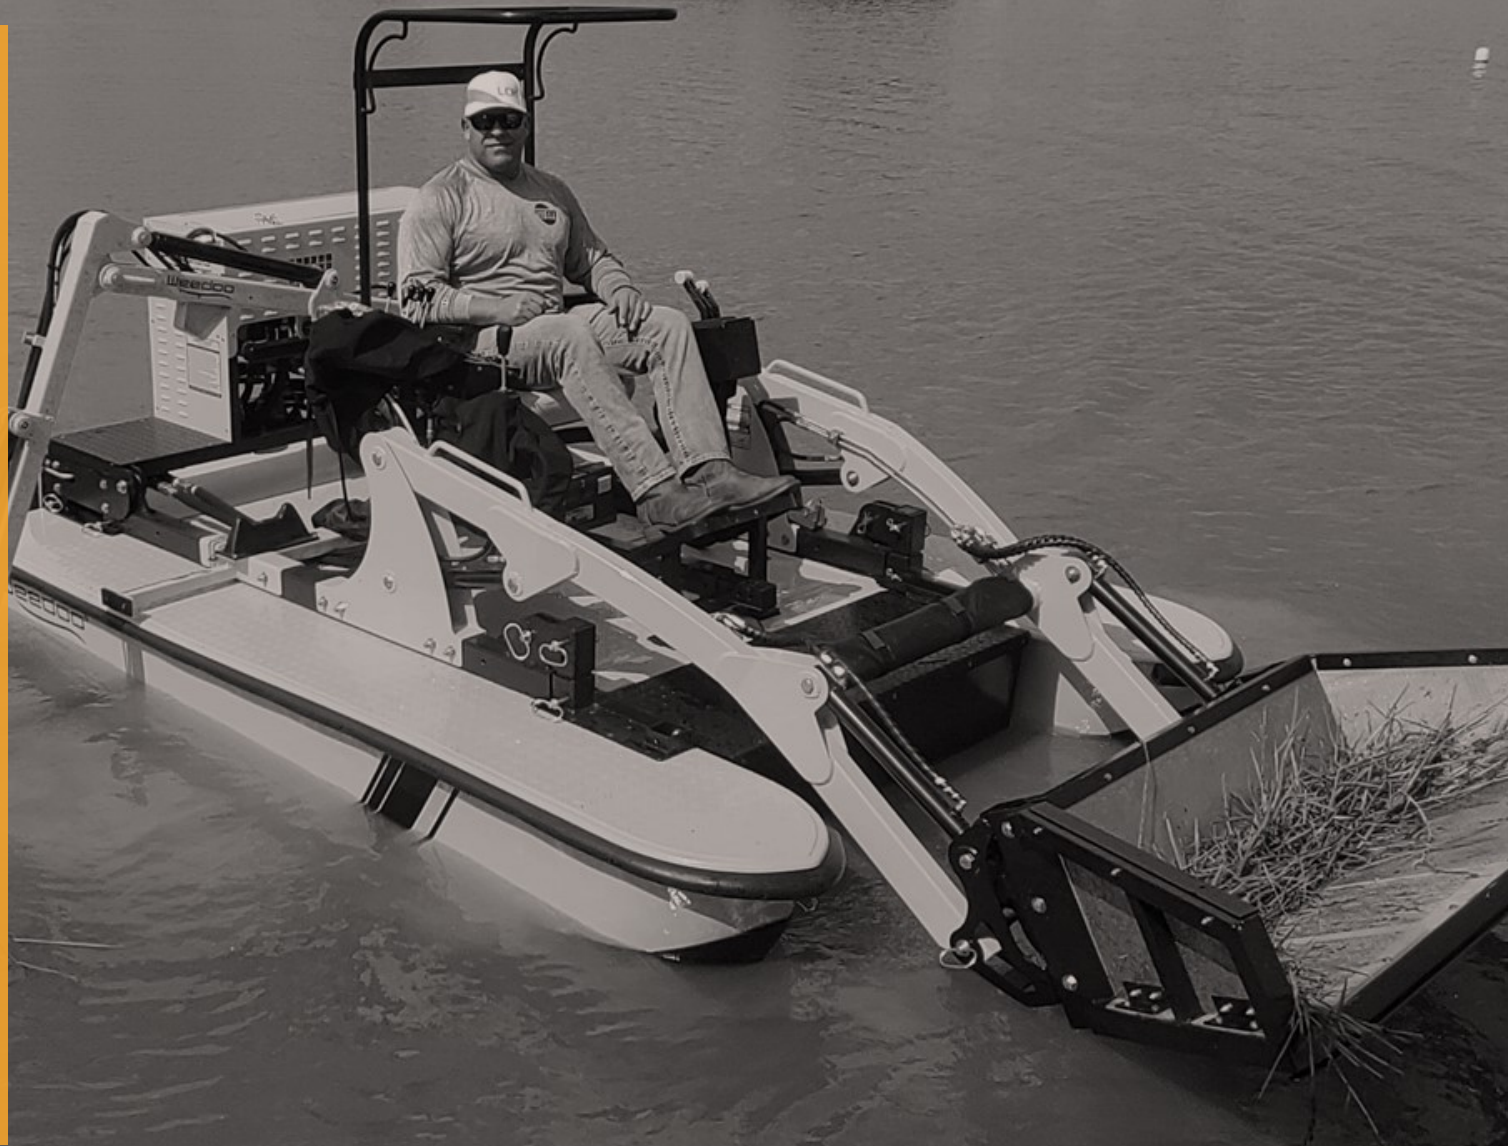
Pond 1 Close to Club House

- Observation
- Thick mats of southern cut grass entangled on creeping burhead in the north east channel, and extensive mats of vegetation extending towards middle of the pond from all shorelines.

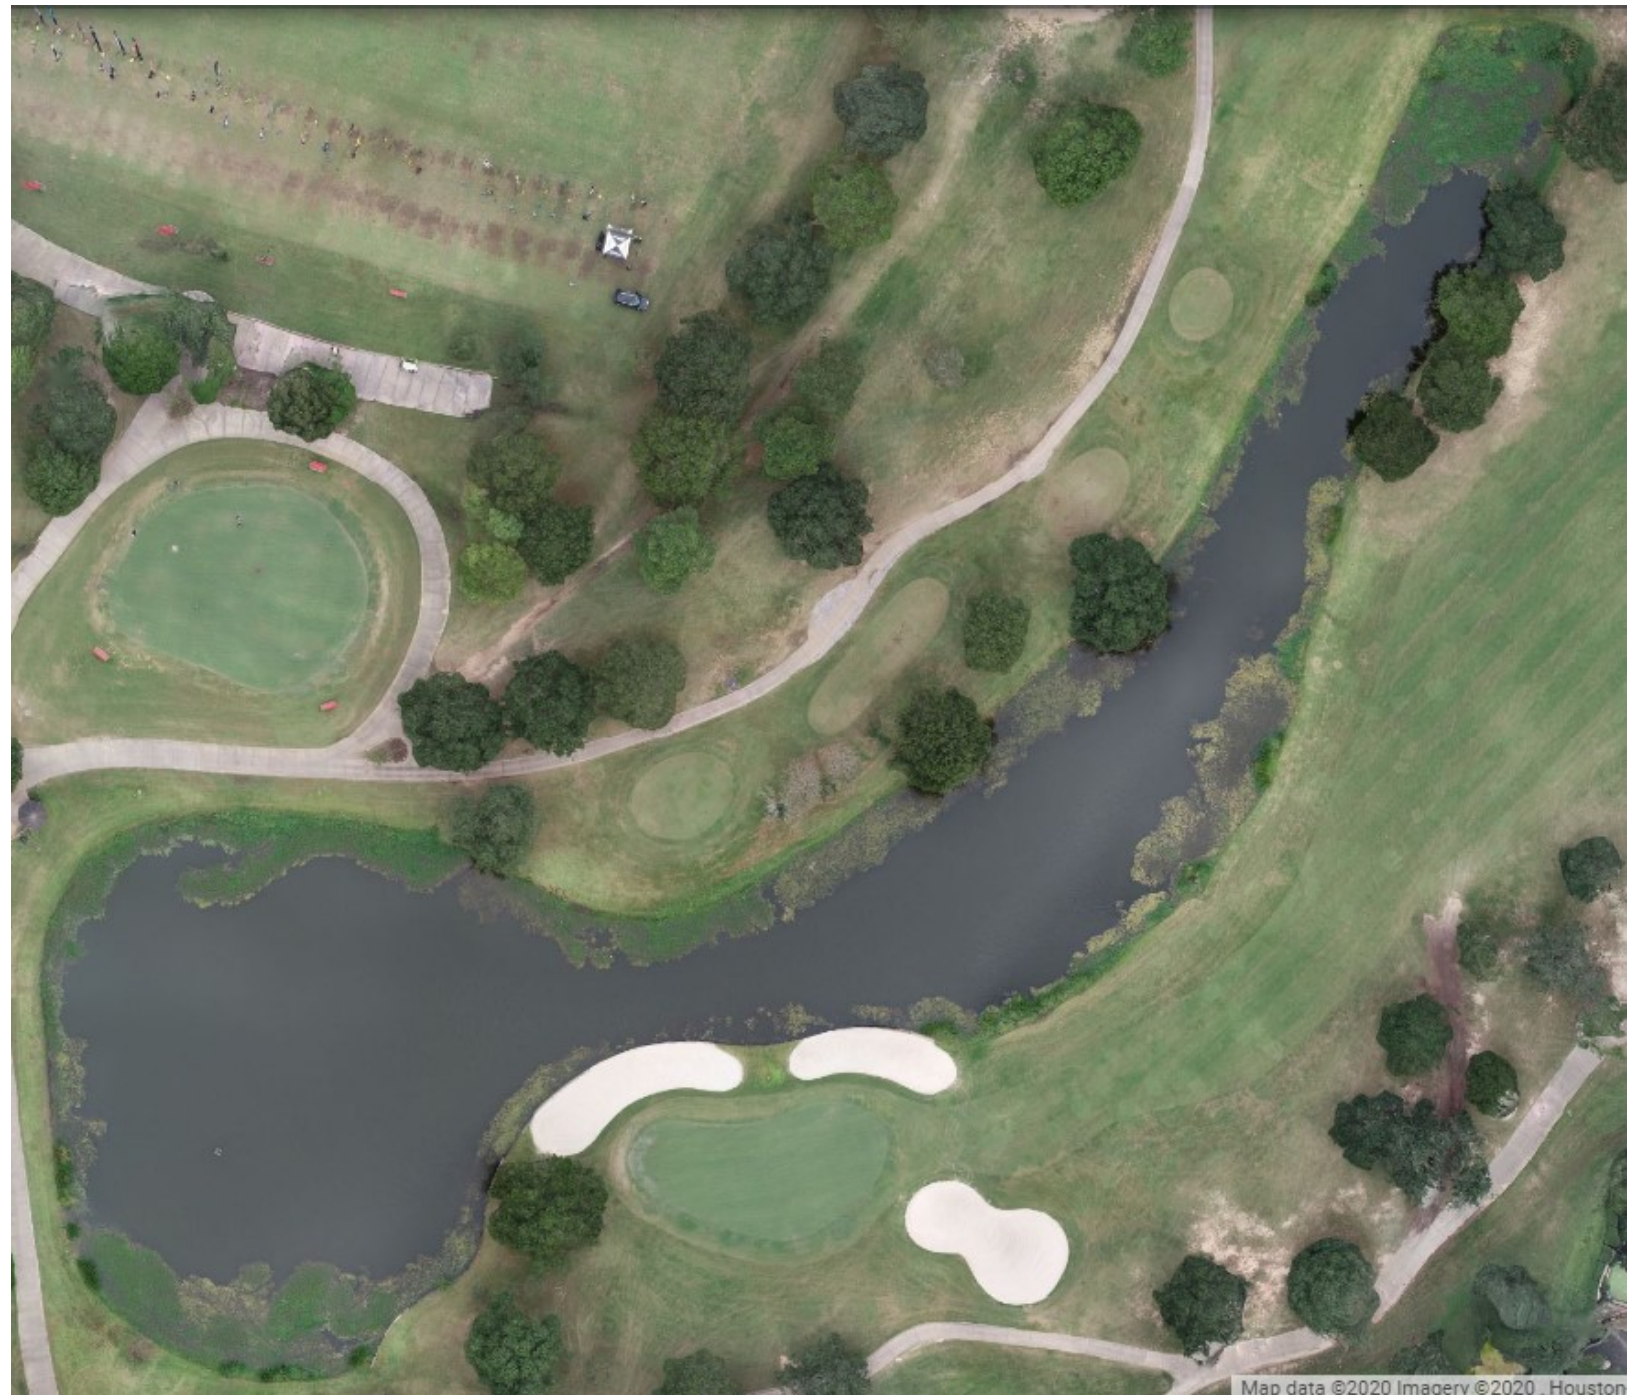
Pond 1 Close to Club House

- Areal Study of affected zones
- Pond Area
- 2 Acres
- Area affected
- .75 Acres
- Percent of pond covered
- 37.5%

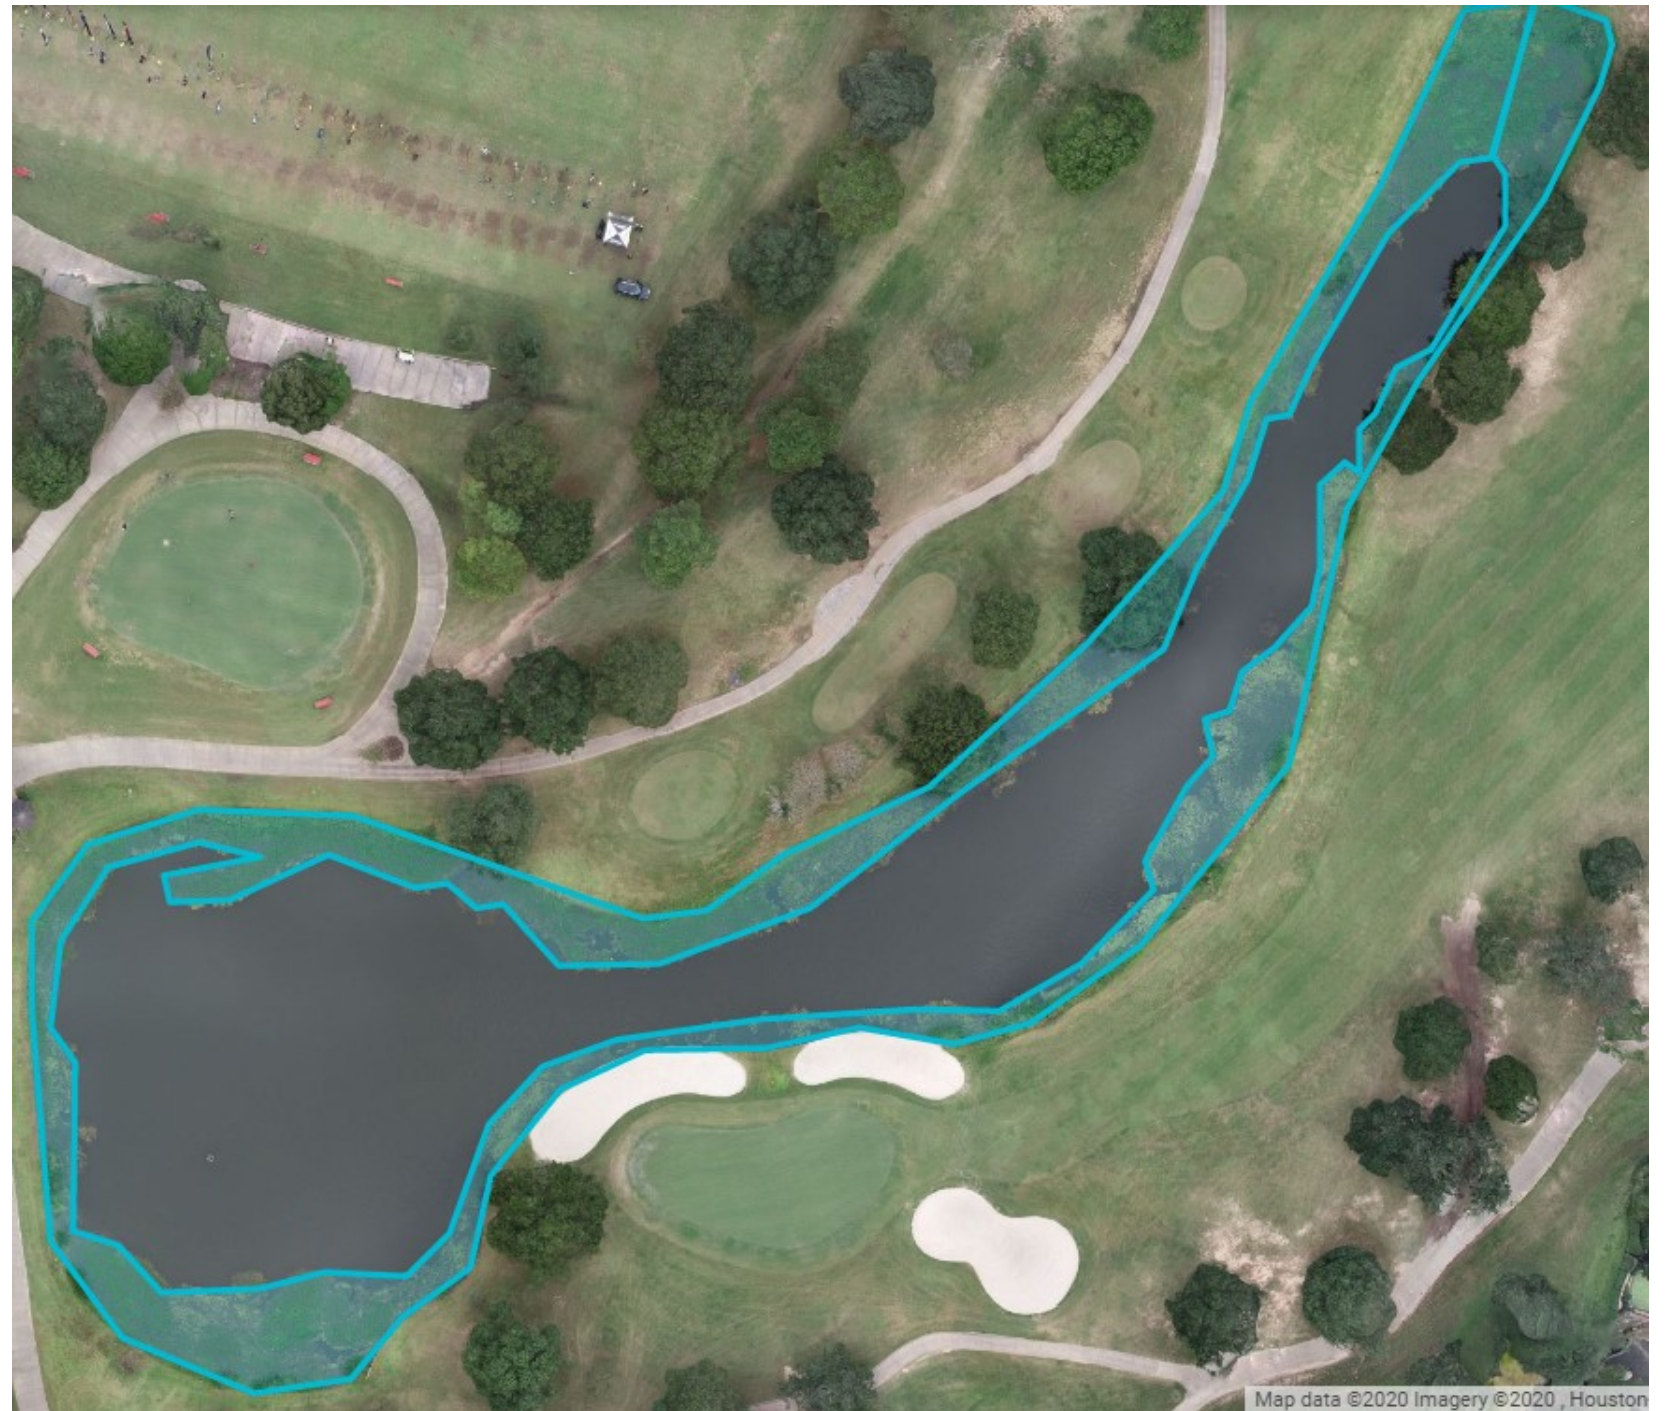
Pond 1 Close to Club House

- Post Cleanup
- Clean up time was 7 hrs
- The picture was taken 2 hours before completion and the machine can be seen cleaning out the last of the north east channel.
- Water clarity should be back in 1-2 days after mud settles

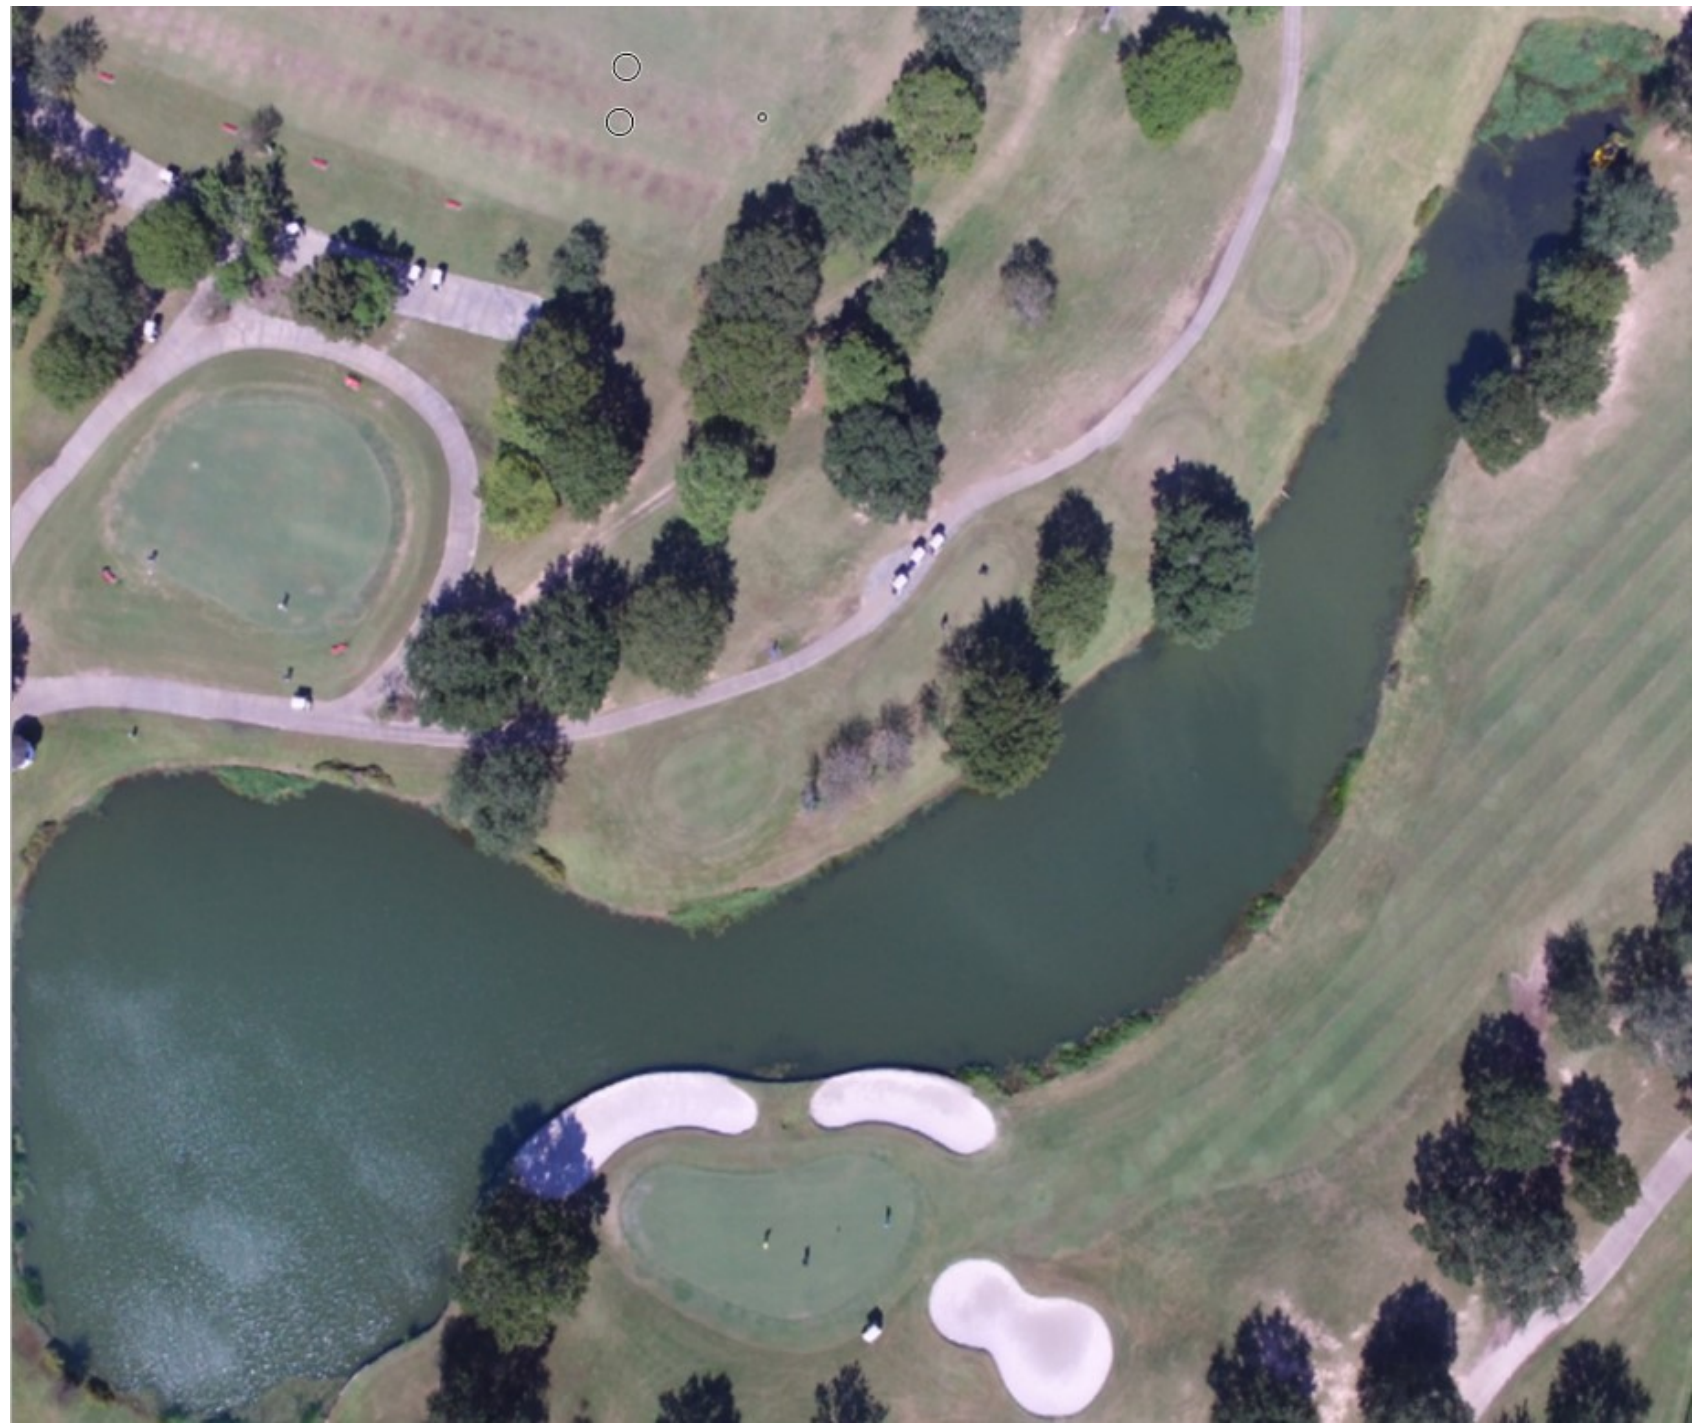
Pond 2 South East of property

- Observation
 - Thick growth of creeping burhead along all of the shores extending 6-15 ft into the middle of the pond.

Also large growth of baby pond weed in the middle of the pond breaking the surface.

Continued mechanical removal of vegetation in the middle of pond 2

Addition of Tilapia in the Spring or Grass Carp to help keep weeds in control.

Addition of Lake dye, 50% black-50% blue to reduce light penetration especially in pond #2

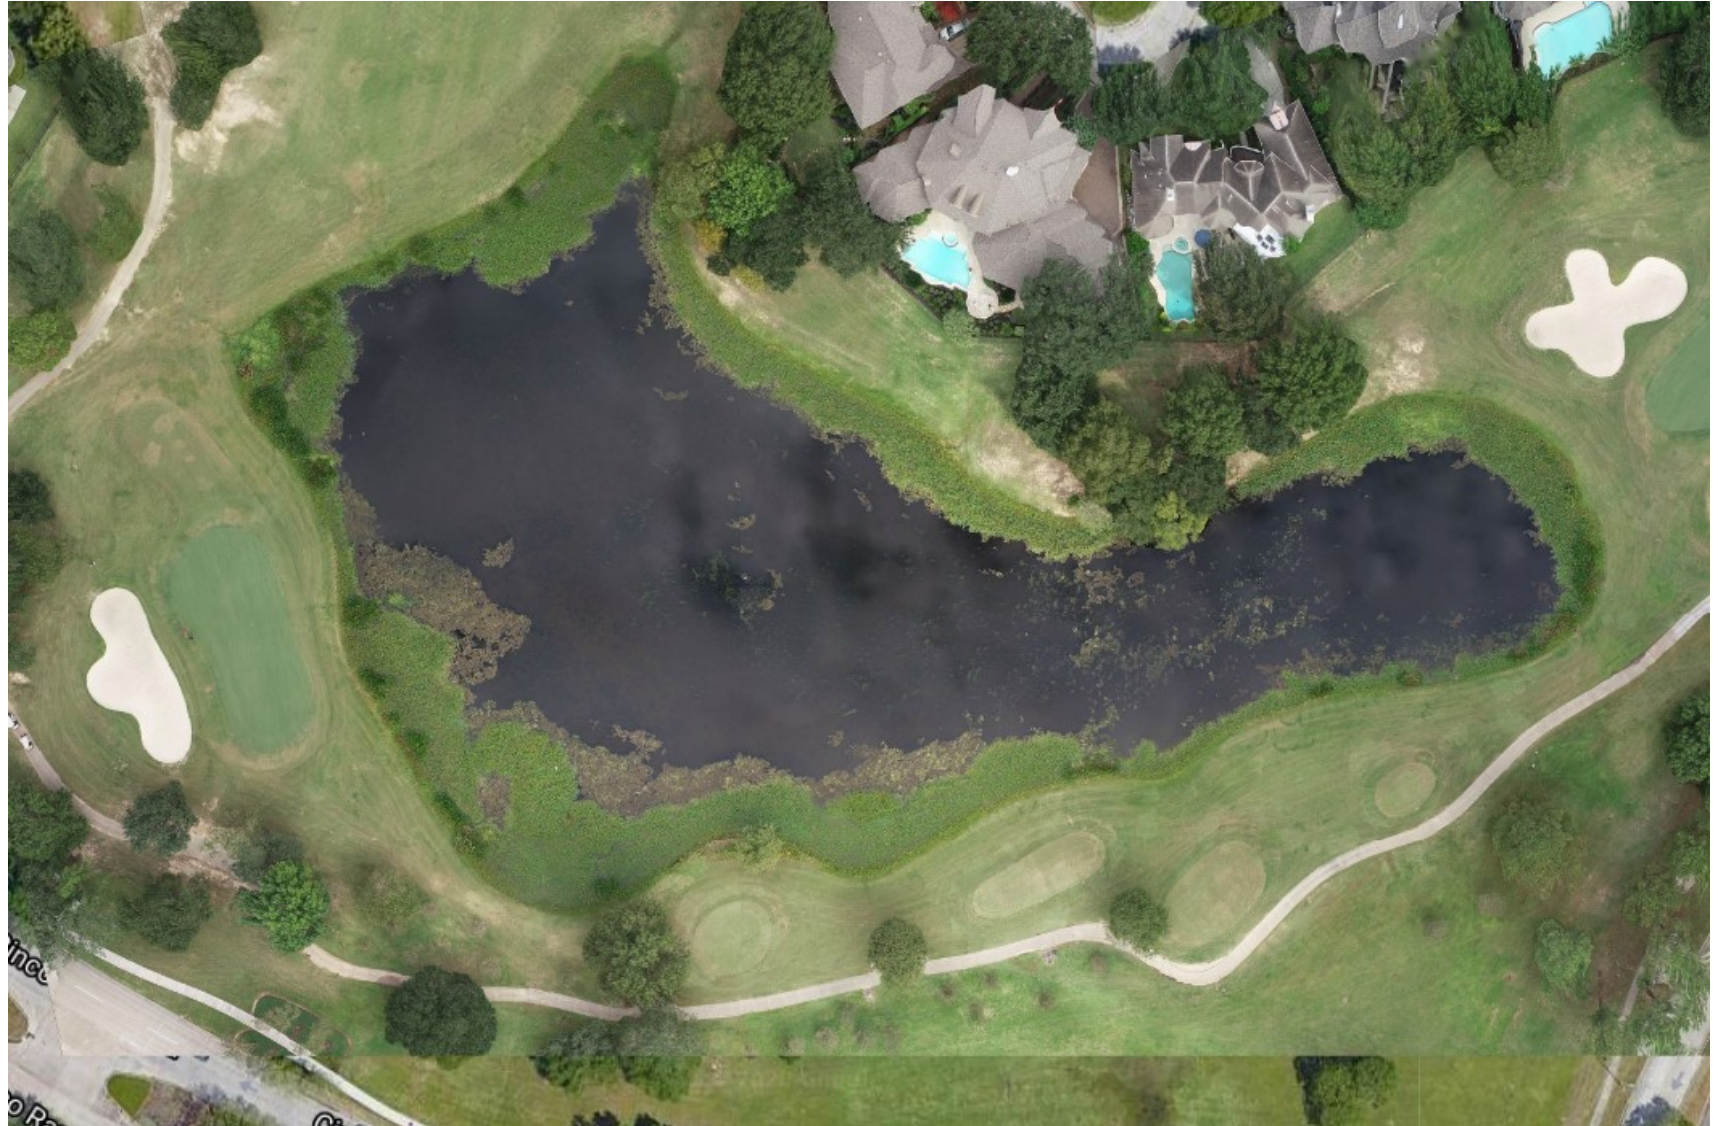
Pond 2 South East of property

- Areal Study of affected zone

Pond Area

2.9 Acres

Area affected

1.2 Acres — Not counting the growth
in the middle of the pond

Percent

41.3%

Estimated clean

up time

9 hrs

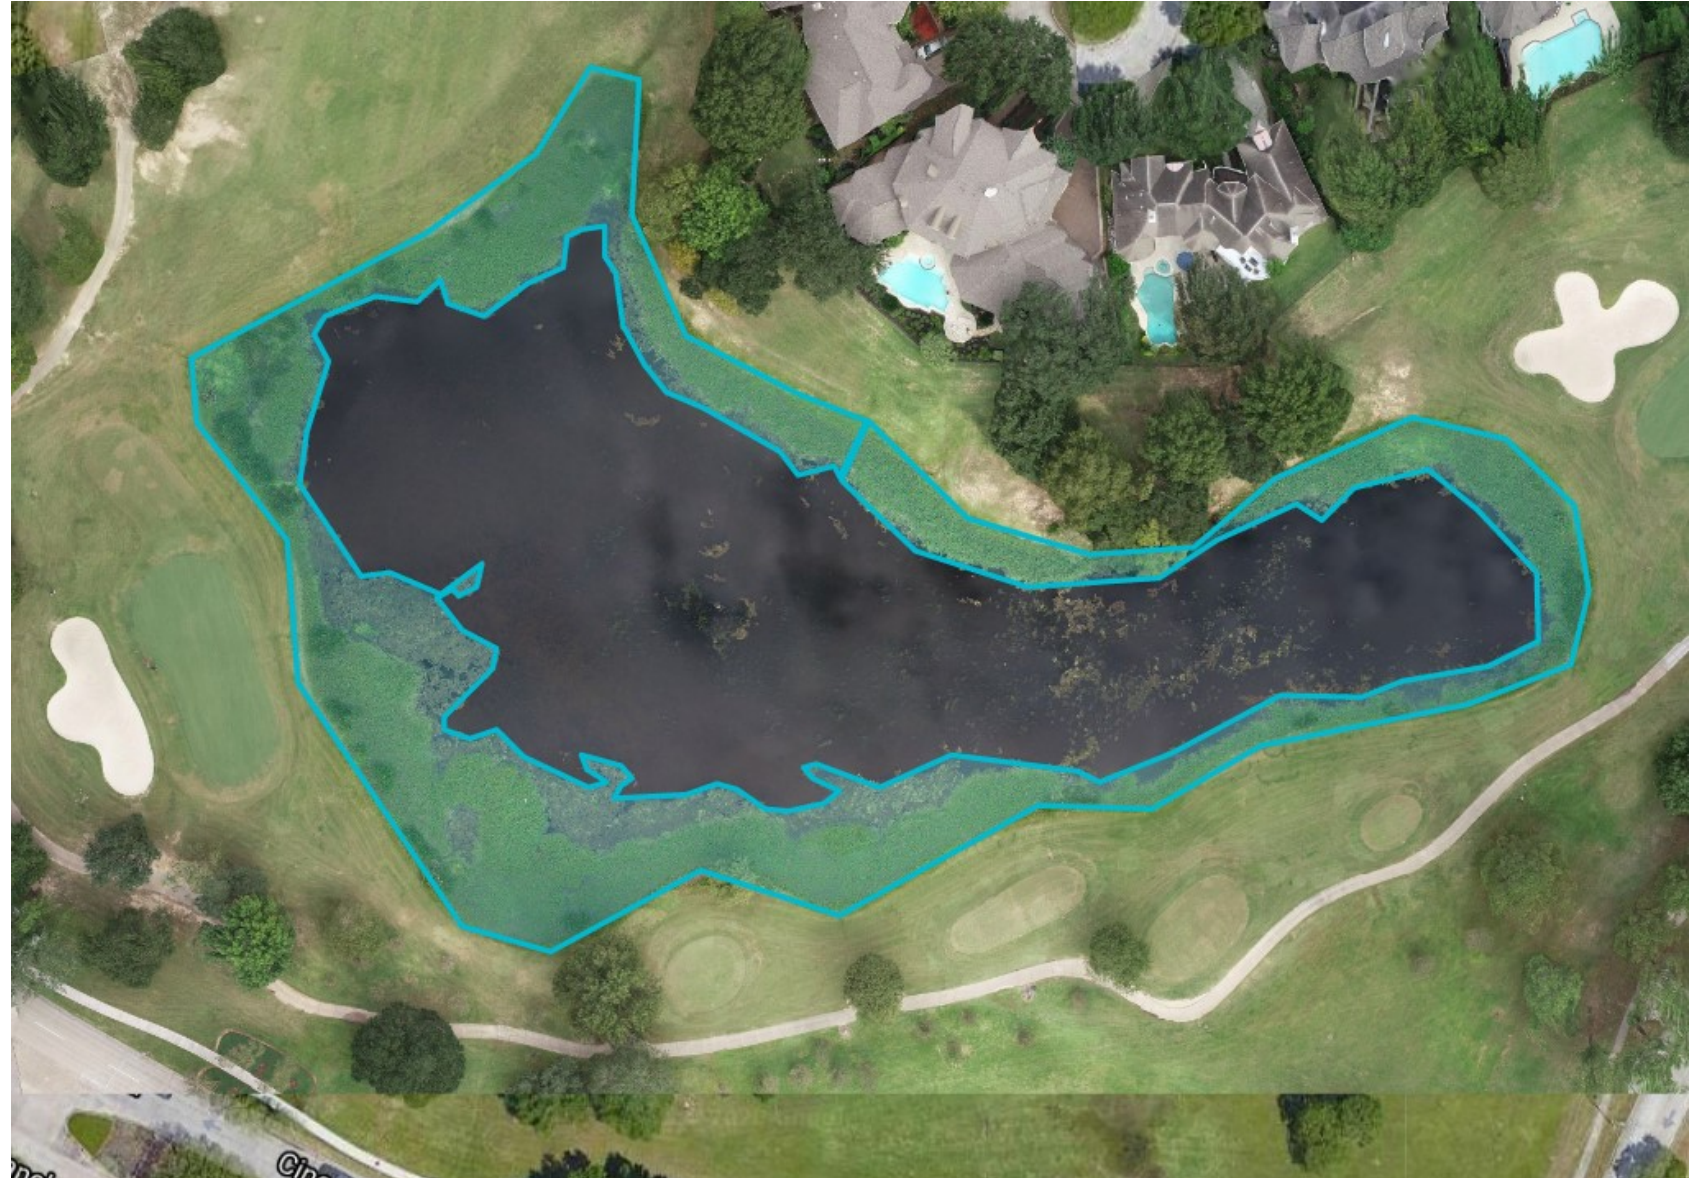
Pond 2 South East of property

- Post Cleanup
- Clean up time took 14 hrs
- There were some areas of brush and cattails that were left on the banks for esthetics purpose. Also a few areas in the middle still need to be removed, but the bulk of the 1.2 Acres was removed and left in easily accessible piles around the pond.
